CAUSE-AND-EFFECT RELATIONS WITH RESPECT TO DEFECTS IN BRICK FIRING IN TUNNEL KILNS

The present study offers theoretical and practical analysis of defect causes and ways for improving production efficiency in firing brick in tunnel kilns at the Al'tair Works of Construction Materials.

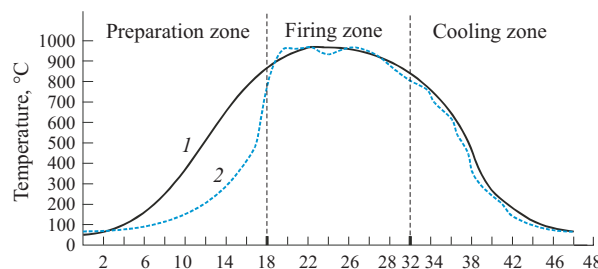
Fig. 1. Theoretical (1) and actual (2) temperature regimes of the tunnel kiln.

The study of the temperature regime along the kiln indicates that the temperature in the preheating zone is below the prescribed value and in front of the firing zone it sharply increases, i.e., the rate of the temperature rise on this particular site exceeds the theoretical rate and the brick is subjected to an abrupt thermal shock, which impairs the quality of firing and increases the quantity of defects.

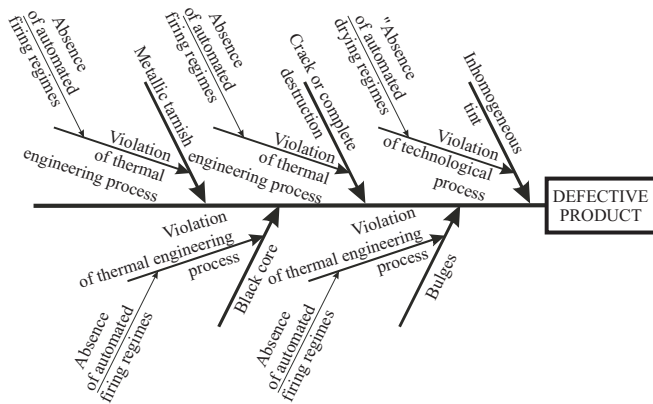
Fig. 2. Cause-and-effect diagrams for the causes of brick defects.

The above types of defects identified in firing brick in the tunnel kiln at the Al'tair Works have been systematized using the Ishikawa diagram [2]. In doing so, a cause-and-effect diagram has been constructed (Fig. 2). It can be seen that the defects in the products are mainly caused by noncompliance with the technological and temperature regimes of the kiln operation.

It should be noted that the heating systems in the brick-firing kiln of the Al'tair Works at the stages of heating, firing, and cooling do not fully match the physicochemical processes occurring in firing ceramics, and the old-fashioned gas burner design prevents maintaining the prescribed temperature regime over the entire cross-section and along the total length of the kiln tunnel.

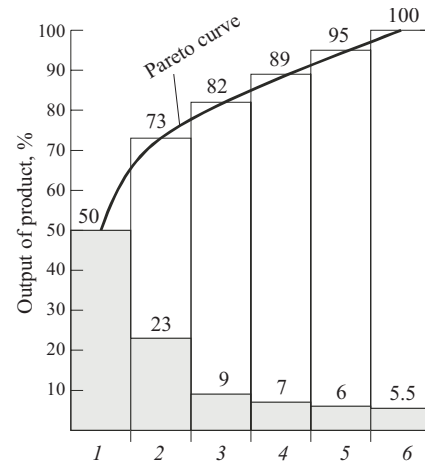
Fig. 3. Pareto diagram for types of defects: 1) metallic tarnish on brick walls; 2) inhomogeneous tint on brick surface; 3, 5) bulges; 4) crack or complete destruction of brick; 6) black core.

The statistical analysis of defects (Fig. 3) shows that they are caused by the violation of the technological and thermotechnical processes due to the absence of automated control of gas-air mixture supply, unstable performance, and imperfect design of the gas burners, and the absence of the appropriate temperature regime in the preheating zone.

In order to avoid defects in firing brick at the Al'tair Works, we propose reconstructing the heating system to take into account all stages of the physicochemical transformations in brick firing. To do so, the existing gas burners should be replaced by modern burners with a wide variation range of the air excess ratio and a high dynamic impulse, which can create the required atmosphere inside the kiln and ensure a uniform temperature across the height and volume of a brick stack. One should pay special attention to the preparation zone, where currently the rate of temperature rise is insignificant and in front of the firing zone this rate exceeds the pre-

scribed value. To solve these problems, burners should be installed in the preparation zone, especially in places where endothermic reactions proceed [3].

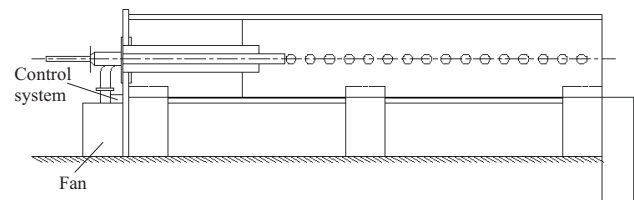
Fig. 4. Testing chamber.

As the first stage of upgrading the tunnel kiln at the Al'tair Works, we have built a prototype plant (Fig. 4) that ensures stable operation of Vulkan-gaz burners.

The plant was tested in production, which established that Vulkan-gaz burners do not provide for optimum mixing of gas and air at the exit from the nozzle; therefore, the final combustion of the mixture occurs inside the chamber, far from the nozzle, and the flame is susceptible to random gas-dynamic flows in the working space of the chamber; the burners are hard to adjust [4].

After the adjusted burners was installed in the kiln, the number of rejected items in brick firing dropped by 15%, the unit fuel consumption decreased by 3%, and the kiln efficiency increased by 1.5%.
